**Title:** Condition Assessment of Marine Structures Treated by Goldseal Anti Corrosive Coating

**Report Number:** 20923.01

**Date Issued:** 7 August 2009

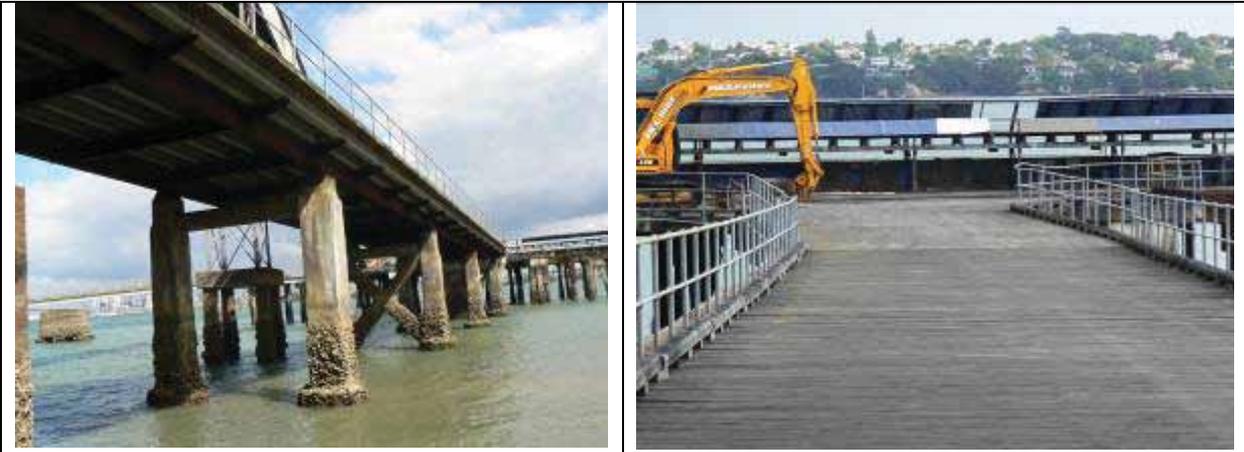
Chelsea Wharf – reinforced concrete pillars, steel substructure with wooden decking.

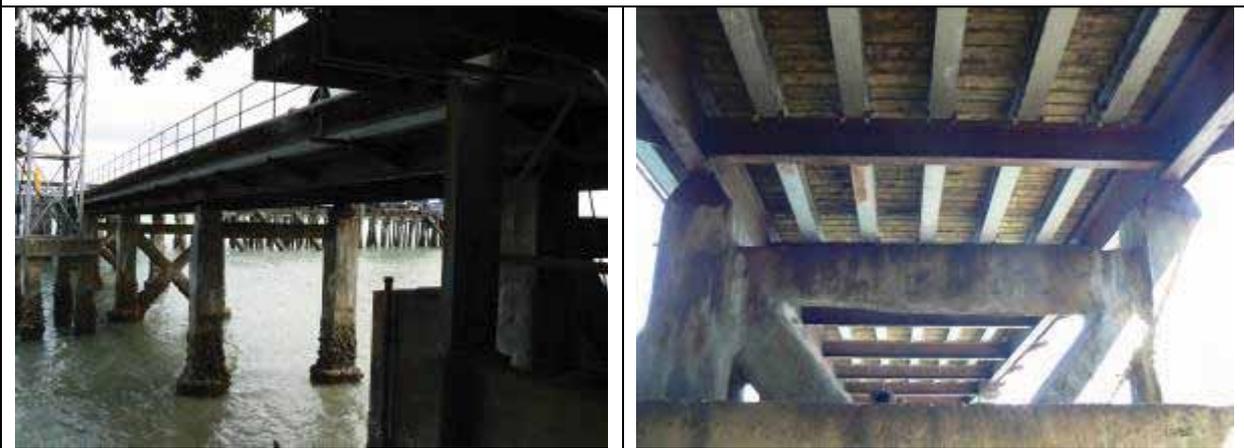
Chelsea Wharf – chlorinated rubber coated and Gold Seal over-coated steel substructure.

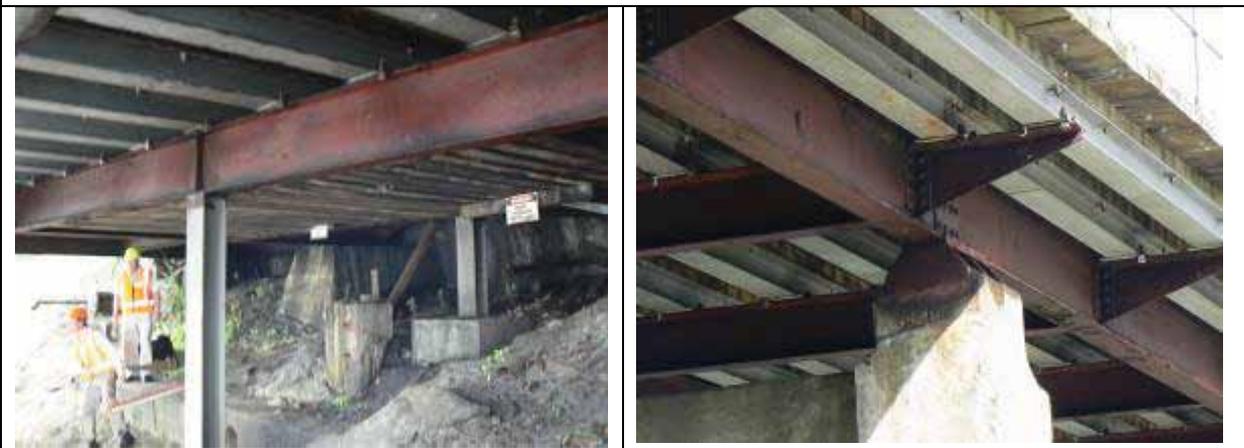
**Figure 1.**

Chelsea Wharf – I-beam construction, Gold Seal coating not reinstated After 2006 modifications.

**The Gold Seal** coating on the Chelsea wharf proved effective and controlling the corrosion on surfaces where it was applied. Those areas where the underlying coating of chlorinated rubber failed were not protected and these areas are recommended to be sand blasted and coated only with the Gold Seal coating. The newly exposed fittings are recommended to be water blasted and locally coated with the Gold Seal.

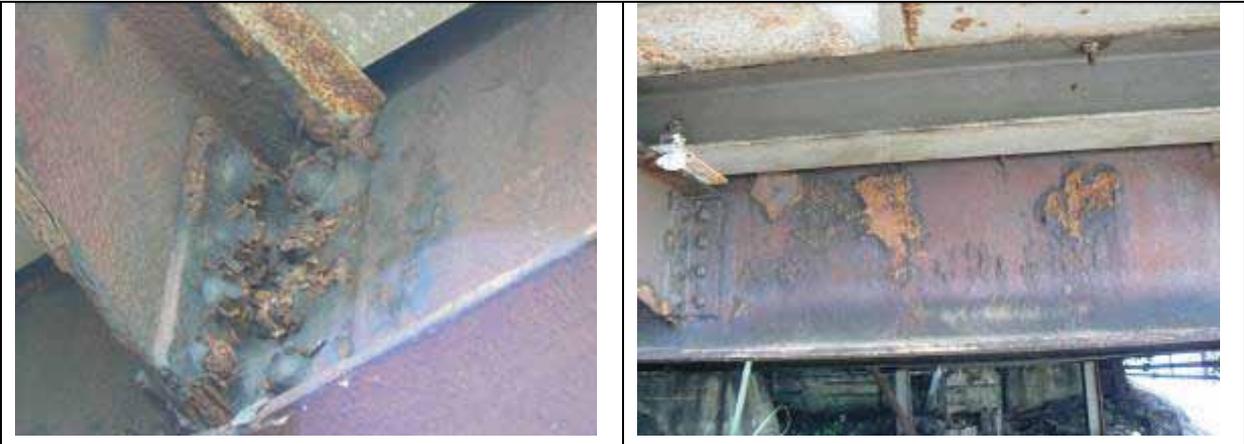
The chlorinated rubber coating was found degraded and cracked (Figure 2) in the areas of excessive thickness and subjected to thermal expansion. The Gold Seal coating was applied on the top of chlorinated rubber coating before the onset of cracking, and hence, there was no direct contact between the Gold Seal and the newly exposed parent material of the I beam. The Gold Seal coating, therefore, was not able to provide corrosion protection to the underlying steel substrate in these areas.

Chelsea Wharf – coating under Gold Seal exhibiting cracking and flaking on rivets and I-beams.

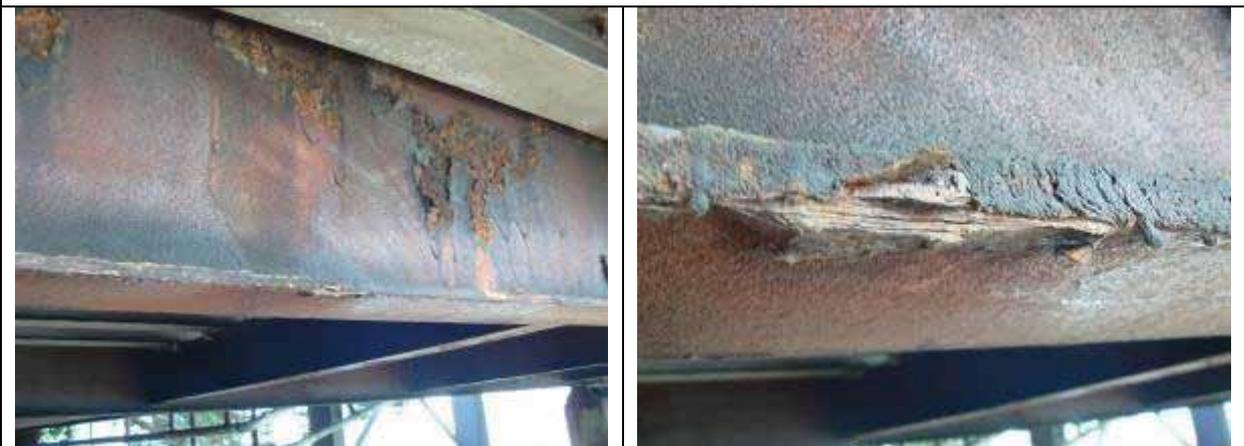
Chelsea Wharf – coating under Gold Seal exhibiting cracking and flaking on I-beams.

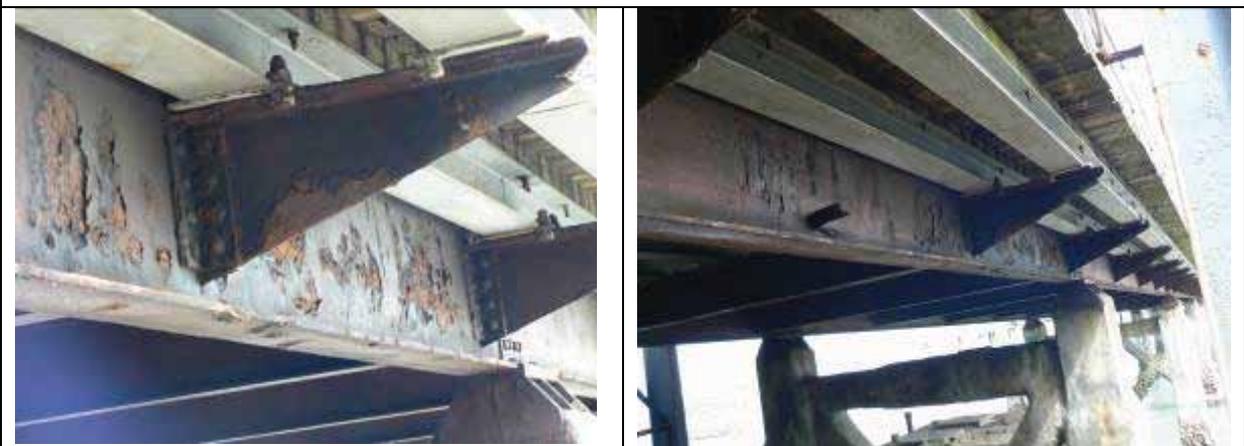
**Figure 2.**

Chelsea Wharf – flaking of chlorinated rubber under-layer.

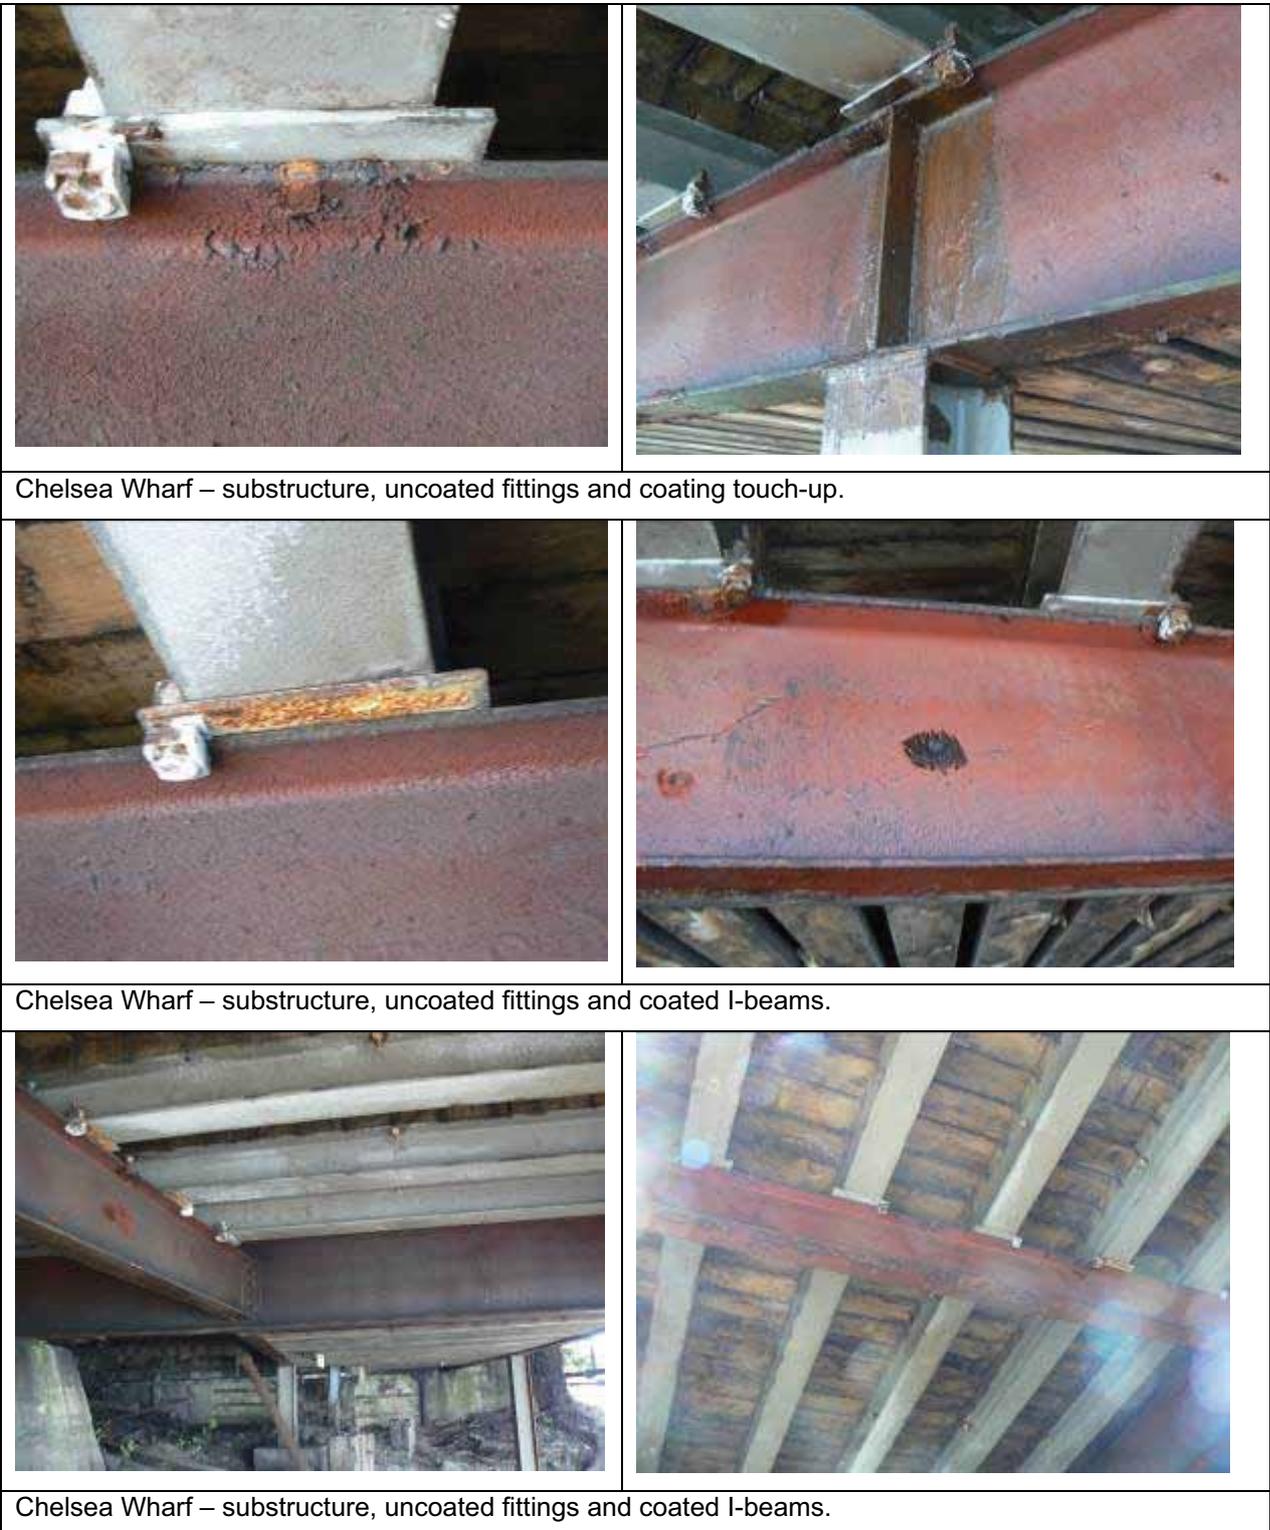
**Figure 3.**

Areas that have been modified during wharf renovation and subsequently treated by the GoldSeal coating showed good performance, while renovations including new fittings that were not Gold Seal coated were experiencing onset of corrosion after six years. This corrosion was manifested in the form of white corrosion products on galvanised fittings, and in some instances by presence of red/brown corrosion products, which are typical of rust (Figure 3).
