**Objective:** To case study the Performance of Goldseal Industrial Hot spray in a highly corrosive environment.

**Background:** Galvanizing plants use a variety of cleaning and pretreatment baths to prepare steel and a hot molten galvanizing bath which gives off clouds of acidic steam upon dipping. Goldseal has over 30 years experience in this environment in New Zealand and Australia and is recognized as one of the few appropriate coatings for this environment.

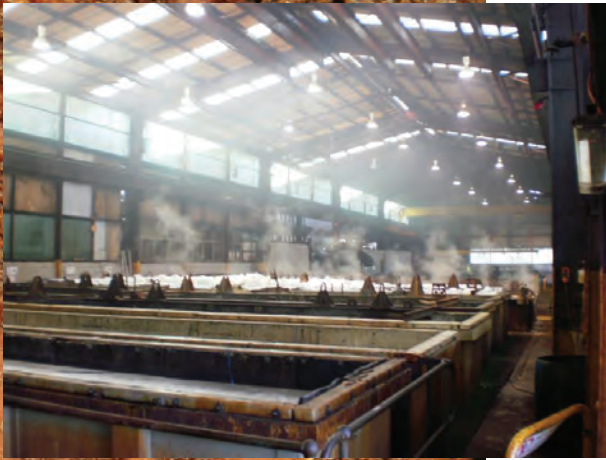
**Case Study:** Galvanizing Plant Western Australia. The rusty cladding is 12 month old prepainted zincalume. The small red topped sheets is an example of rusting cladding that was Goldsealed 5 years earlier. The steel purlins were Goldsealed at the same time. From the time we were asked to quote on the new cladding rust, it had rusted through before we had time to arrange a shut down window.

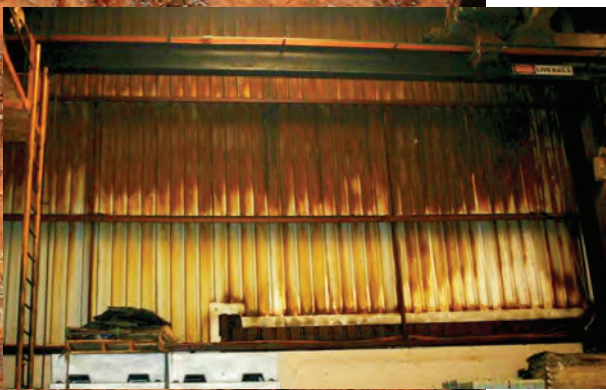
**Case Study:** Queensland Australia. A good example of the right products used to give long service life in this environment

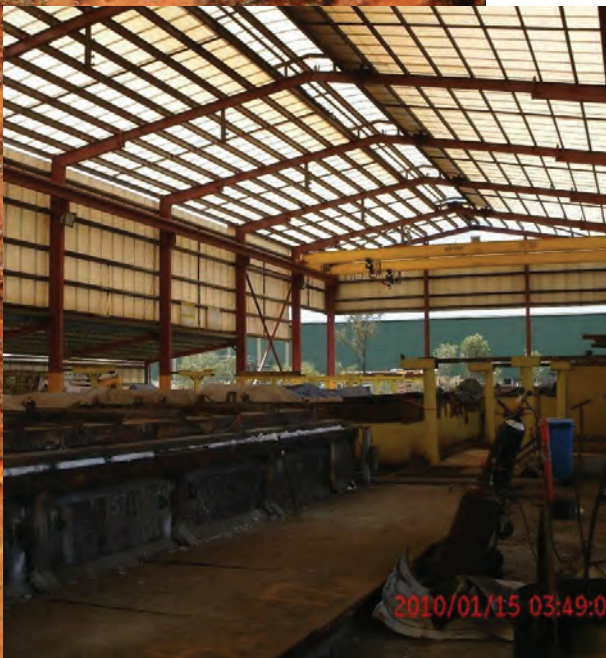
**Case Study :** Galvanizing plant New South Wales Australia. Portals and steel purlins can be coated in a cost effective and time effective manner. Galvanizing plants are not large and much can be achieved in a long weekend shutdown. Goldseal is a very effective rescue coating on C or Z purlins. During the coating process if any purlins are found to be beyond rescue they are left uncoated. These individual purlins can then be replaced or sleeved without the need for roof removal. Production is maintained.

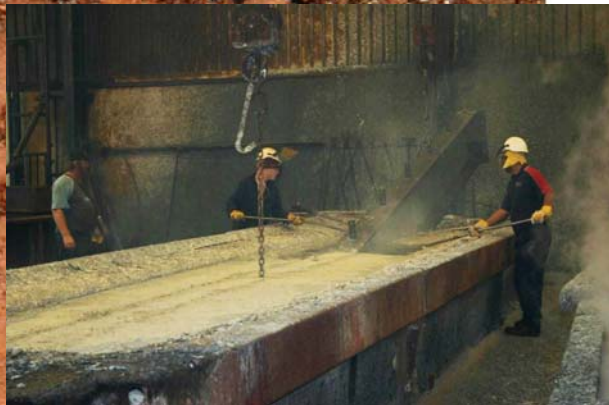
**Case Study :** Galv Plant Hexam Australia. The plant manager here had experienced Galvanizing and fitting their own structural components. In the processing area the new Galvanizing was sacrificing itself after 3 years. Any new components from then on were galvanized and coated new with Goldseal Hotspray. The trial ran for 12 years and the Goldseal was then recoated with only a wash down to the uncorroded surface.

All structural steel components are Goldsealed including Crane rails.

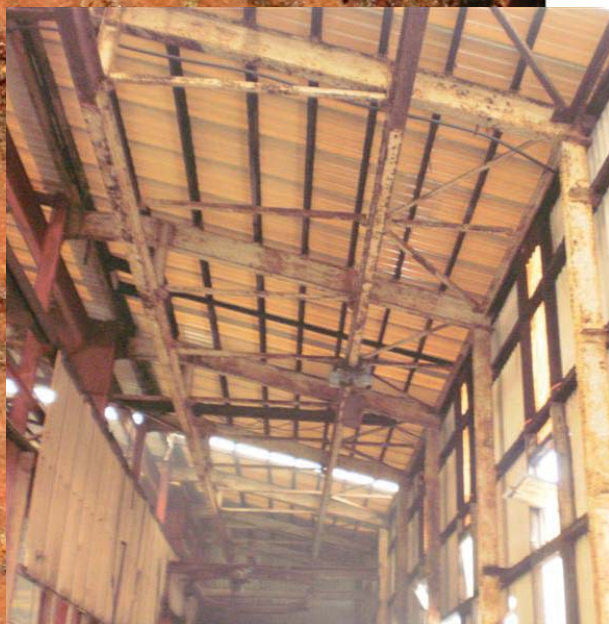
While wooden purlins deliver an acceptable service life in an acid environment, there can be erosion of the wood fiber, with time.

We recommend complete encapsulation with Goldseal at this stage in life.

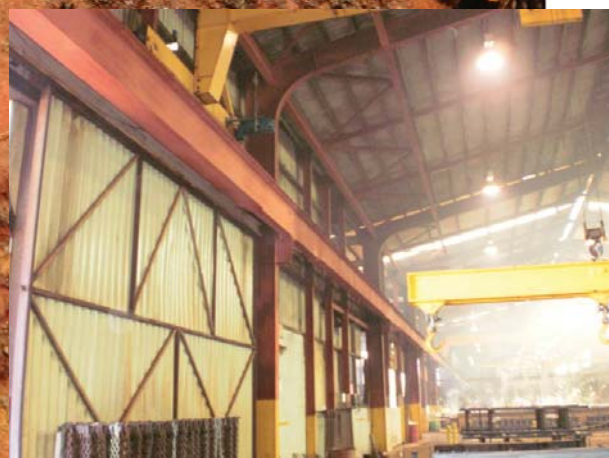
Goldseal CSI Technology will penetrate the surface and protect, in much the same way as steel and also seal the flange / bolt area.
